## The effects of almost 20 years of operation on the performance of the Aberystwyth MST Radar

book title Proceedings of the Twelfth International Workshop on Technical and Scientific Aspects of MST Radar  
 pages 119 - 122  
 year 2010  
 editors N. Swarnalingam and W. K. Hocking  
 publisher Canadian Association of Physicists, Ottawa, Ontario, Canada  
 ISBN: 978-0-9867285-0-1  
 url <http://www.cap.ca/en/publications/conference-proceedings>

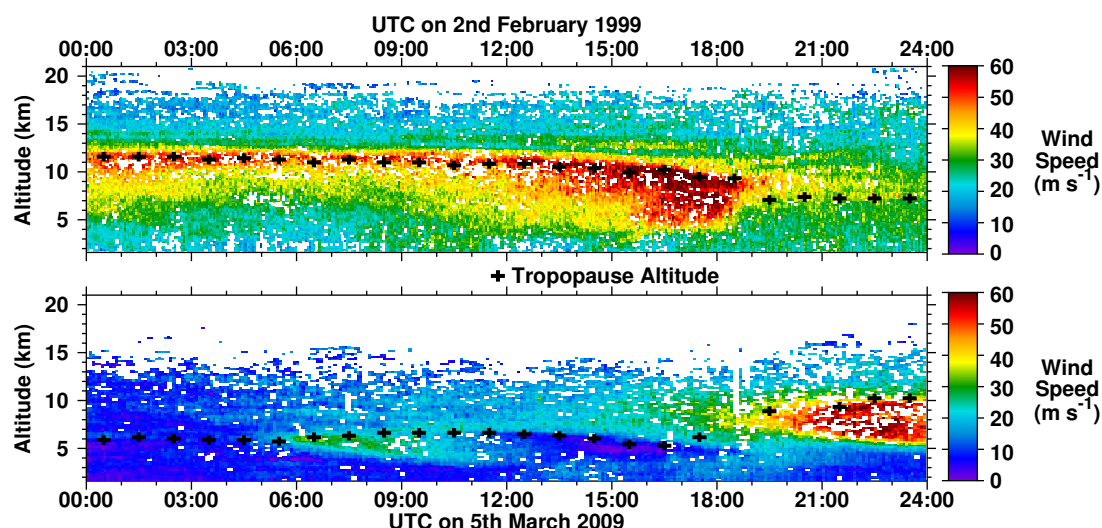
Figure 1: An illustration of how the maximum useful altitude for wind-profiling purposes has reduced from nearly 20 km in 1999 (top panel) to around 15 km a decade later (bottom panel).

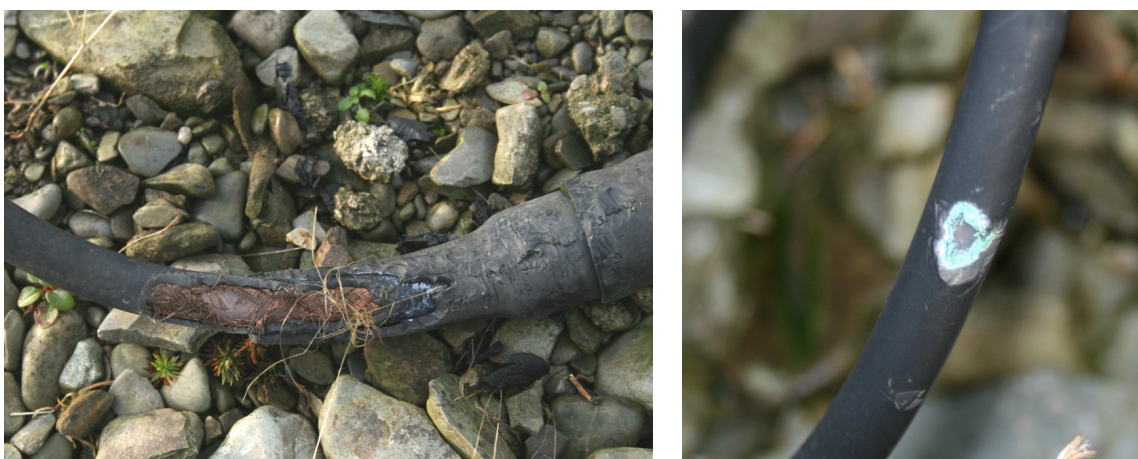
Figure 3: Examples of vermin damage to RG 213 cables.

of the five identical transmitters. The signal from each transmitter is distributed equally to each Quad within the sector using a cascade of power splitters. Most of the interconnecting cables are of type LCF 7/8" or LCF 1/2". They are primarily routed underground, but those sections which are visible appear to be in a good condition. The final sections of cable are of type RG 213. Some of these show signs of mild vermin damage and the outer PVC jackets of all of those inspected show signs of degradation due to solar UV light and leaching of plasticiser.

In conclusion, after twenty years of operation, the Relay Units, the Relay Control Cables, and all RG-213 RF cables have reached the end of their useful working lives and are in urgent need of replacement. Moreover, it would be highly desirable to replace the Relay Control Unit since its almost-complete lack of documentation will make it difficult to repair in the case of a failure.

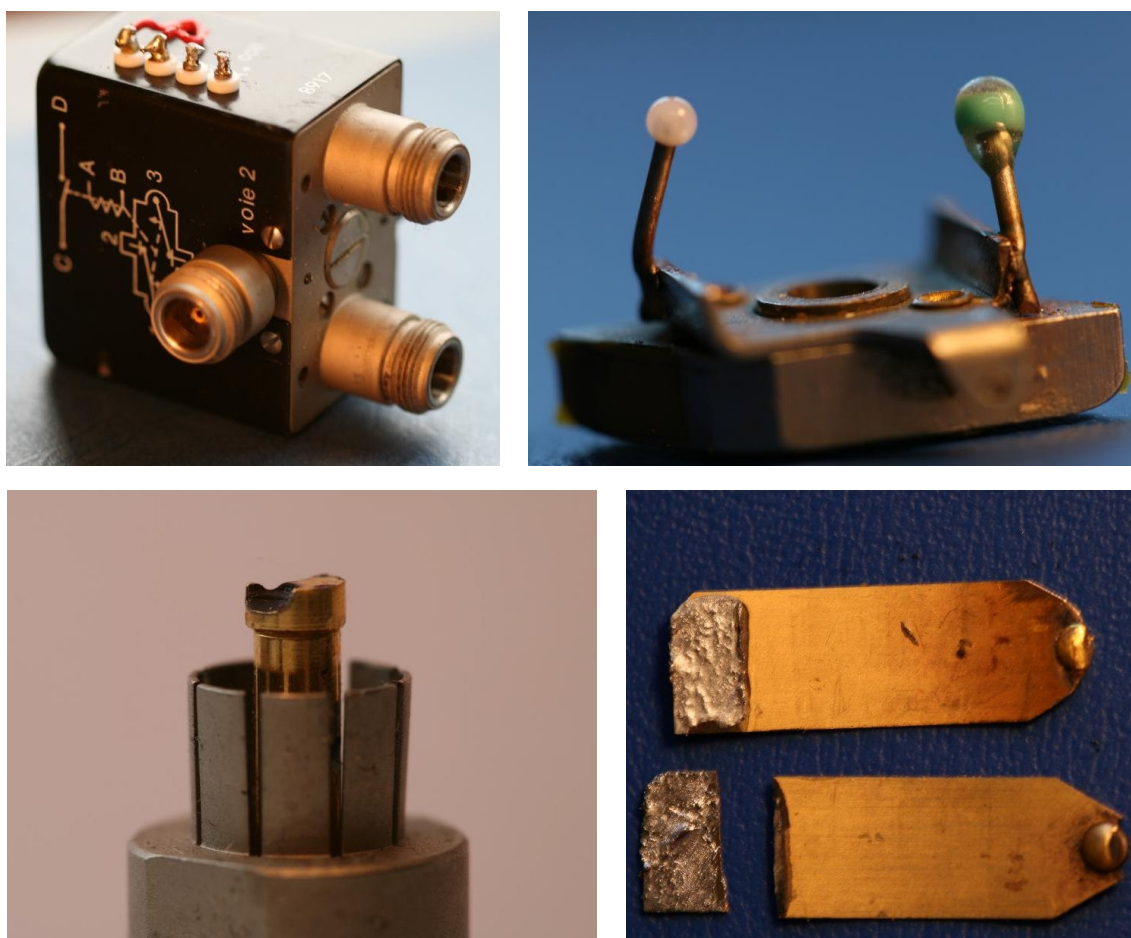
Figure 4: (top left) A complete relay unit; (top-right) the rotor mechanism; (bottom-left) an RF cable connector contact pin which has suffered from severe contact erosion; (bottom-right) an intact and a snapped contact blade.

The Relay Units in use today are all from the original stock, which included a number of spare units. They each perform approximately a million switching operations a year. Consequently they are subject to continuous, albeit gradual, degradation. The most common problem is an increase in the mechanical resistance experienced by the rotor mechanism (top-right panel of Figure 4). This can be solved by simply removing the accumulated debris (principally metal filings) from around the mechanism. Occasionally the rotor pins snap off. A new pin, which uses the plastic bead from a child's toy necklace as an insulator, can be welded back on as a replacement. The pin with a white bead seen in the top-right panel of Figure 4 is an original, whereas the one with a green bead is a replacement.

A more serious problem is that Relay Unit contacts are prone to erosion. RF arcing, which leads to evaporation of the contact metal, is believed to be responsible. As shown in the bottom-left panel of

Figure 4, this is a particular problem for the contact pins at the back of the RF connectors. The degree of erosion can range from being superficial through to the loss of material to a depth of over 1 mm (the contact pins are approximately 3 mm in diameter). The lifetime of a connector can typically be extended by rotating it slightly so as to present a more-robust portion of the pin to the contact blade. Nevertheless, a number of connectors have become so badly eroded that they have had to be removed from service. The contact blades (bottom-right panel of Figure 4) are also prone to contact erosion, albeit to a lesser degree. Nevertheless, they also have a finite lifetime and must be removed from service when they snap (as in the lower example).

Some of the longest relay control cables, which run over 100 m to the western side of the antenna array, have been found to significantly attenuate the voltage (28 V) generated by the Beam Steering Unit. The Relay Units have a specified minimum of 24 V for switching to take place, whereas some of the measured voltages are as low as 21 V. It is not clear as to how much this is a result of the vermin damage. Regardless, such low voltages are likely to result in sub-optimal contact pressure of the Relay Units and so could be aggravating the problems described above.

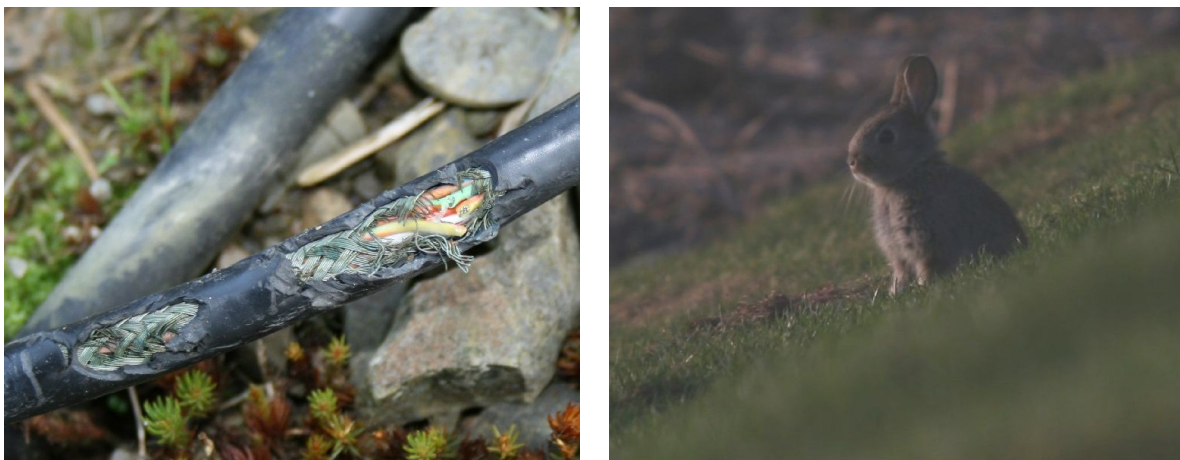
Figure 5: Examples of (left) a vermin-damaged relay control cable and (right) one of the probable culprits.

A single 18-core control cable connects each of the 100 Phasing Units to the Beam Steering Unit. They are primarily routed underground but are visible in the vicinity of their destination Phasing Units. Many of these sections show signs of vermin damage. In mild cases only the braiding wire is exposed. However, in a few severe cases, such as the one shown in the left panel of Figure 5, the copper of the individual wires is exposed. Most of this type of damage appears to be confined to the NE quadrant of the array. Rabbits (see right panel of Figure 5), which are plentiful on the site, are thought to be the primary culprits. No active steps have been taken to control the on-site population owing to fact that it would be difficult to prevent re-colonisation at this rural location.
